OPERATION PLUMBBOB

NEVADA TEST SITE
MAY-OCTOBER 1957

Project 30.7

TEST OF GERMAN UNDERGROUND
PERSONNEL SHELTERS

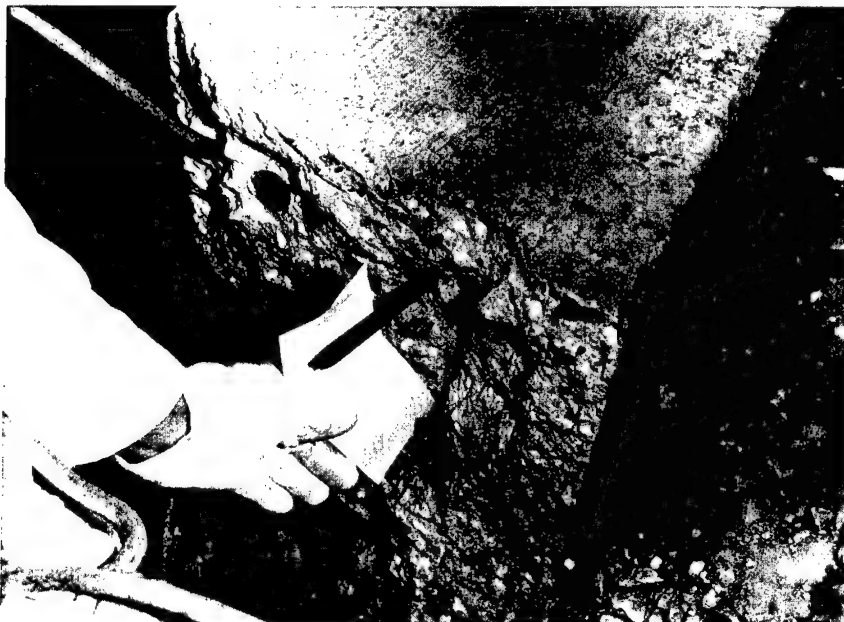
Fig. 3.20—Detail of necked-down reinforcement torn from parapet at interior wall (structure RAa).

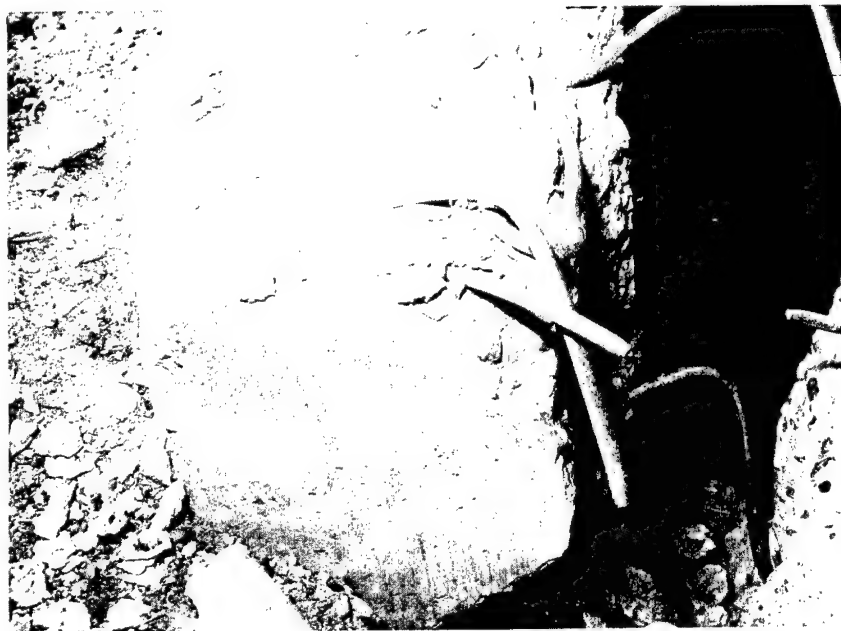
Fig. 3.21—Detail of necked-down reinforcement torn from interior wall at parapet (structure RAa).

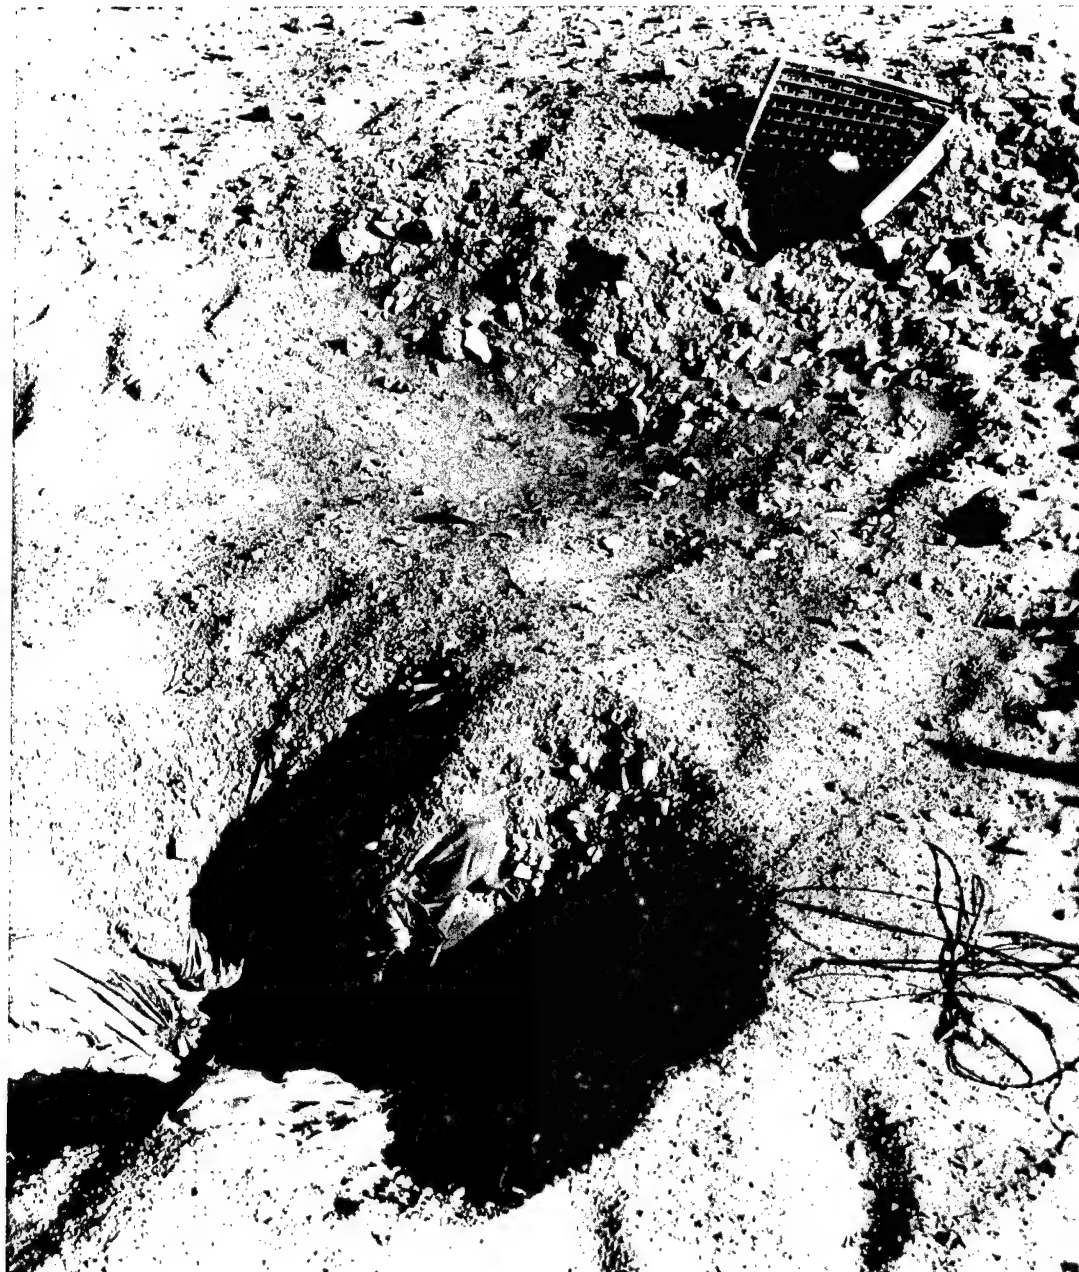
Fig. 3.23—Above-ground portion of ventilation shaft and main entrance (structure RAa).

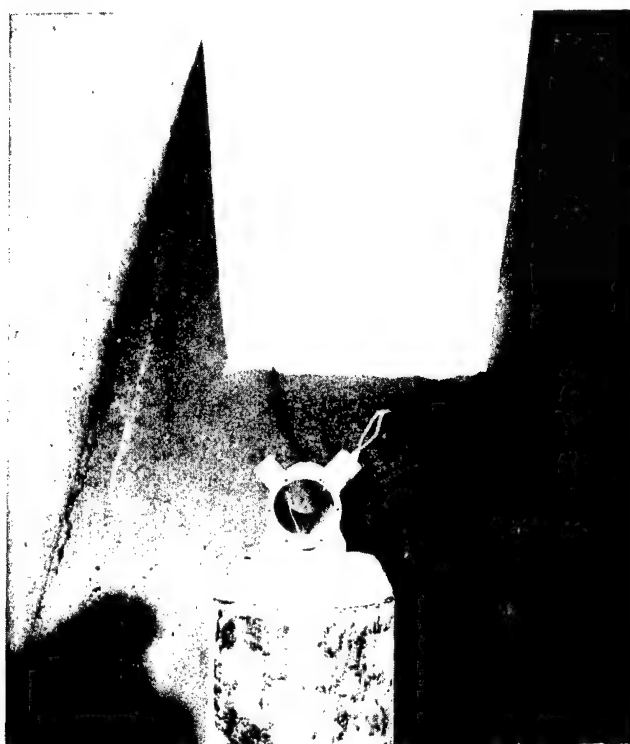
Fig. 3.48—Detail of cracks at intersection of parapet wall and interior wall and entrance facing away from GZ (structure RAc).

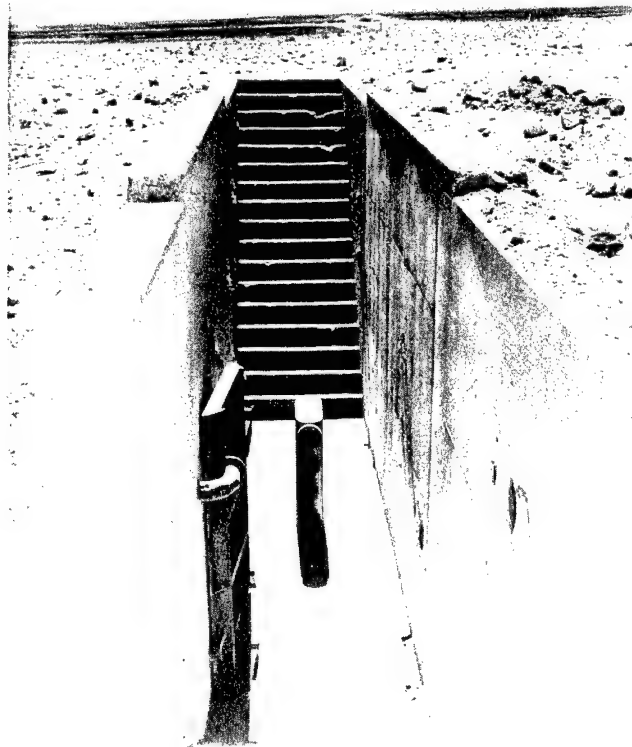
Fig. 3.89—View of main entrance after cleaning away debris, looking away from GZ (structure RCa).

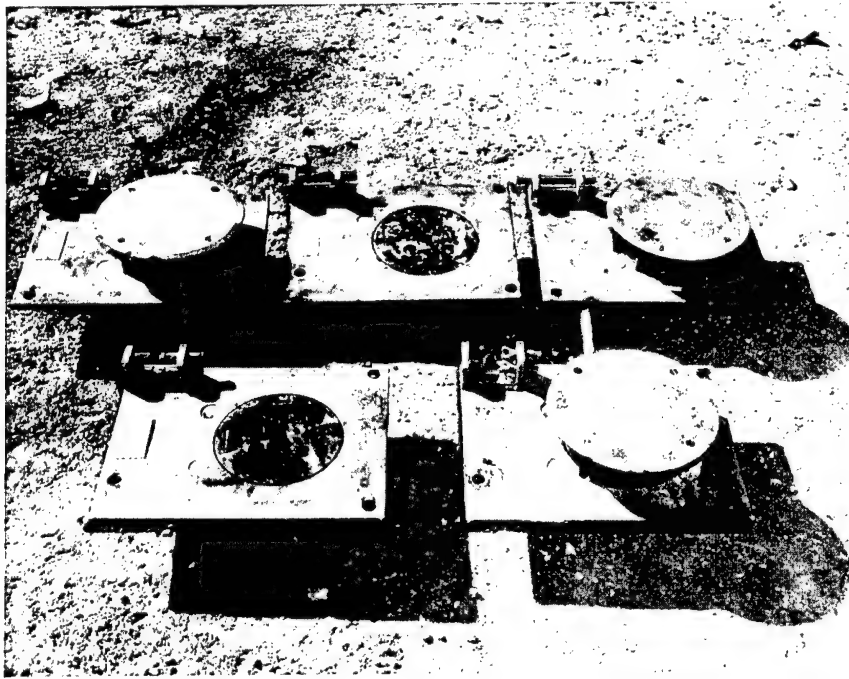
struments is given by Project 30.5c in report WT-1536. Figures 3.110 to 3.116 show the condition of these gauges after recovery from their field locations.

Fig. 3.110—German pressure gauges 1 to 5, following test.
